FATIGUE TESTING OF HARDBAND PRODUCTS ON HWDP CENTER WEAR PADS

Testing reveals that tungsten carbide in a mild steel matrix is one of the worst choices. Duraband® NC and Tuffband® NC exhibit outstanding fatigue life.

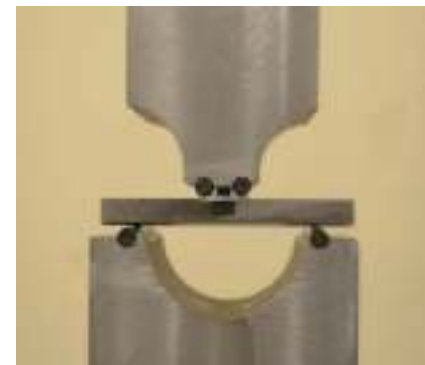
Fig. 2 A fatigue test sample mounted in the special designed fixture (4 point loading).

Various loads were applied to arrive at a level that would yield repeatable data. The ideal load was determined to be 2400 Lbs to 240 Lbs at a frequency of 30Hz (see Fig. 2).

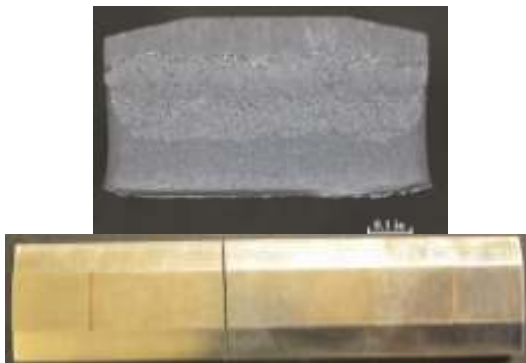
Fig. 3A Duraband® NC. The sample was brought to failure after 1,000,000 cycles. The upper photo shows the cross-section of the fractured surface. Note that there are no flaws in the weld deposit, which produces desirable fatigue failure results. The lower photo shows no flaws in the weld deposit that could produce premature fatigue failures.

Duraband® NC & Tuffband® NC : All Tuffband® NC and Duraband® NC samples were clean of any blemishes or flaws prior to testing and achieved 1,000,000 cycles, when the testing frequency and load were terminated (see Fig. 3A & 3B).
