Why do some hardbands crack?

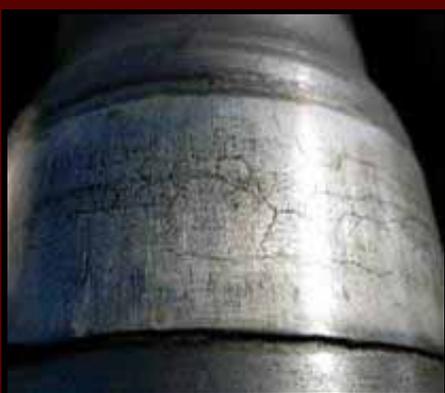
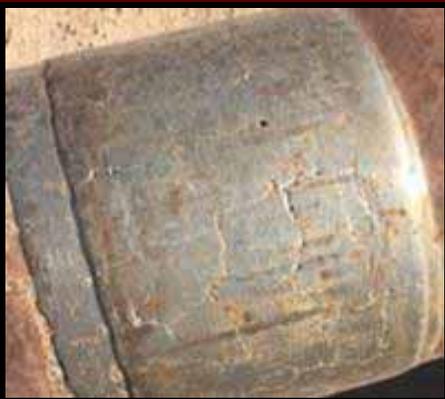
The photos above are two examples of hardbands exhibiting unacceptable cracking. Hardbanding in this condition should never have new hardbanding re-applied over them. It must be ground out and rebuilt before new hardbanding can be applied.

The best way to avoid cracking is by using a stable and non-cracking hardbanding wire such as Duraband, welding over an existing non-cracking and compatible surface, and paying close attention to the proper welding parameters.
