<u>Remove, Repair, and Hardband in 35 Minutes</u> <u>with Skye – Laboratory Tested</u>

This procedure is designed for field removal, repair and hardband application, where Magnetic Particle Inspection (MPI) is not available, and visual inspection between processes is the only available option. Samples have been laboratory tested to ensure resulting hardness in HAZ, Tool joint, Build-up, and Hardband are acceptable. This test was conducted with one pass on plasma and one pass on build up as that was all that was required. More complicated jobs may need more than one pass of each process. For more information <u>colin.duff@hardbandingsolutions.com</u>

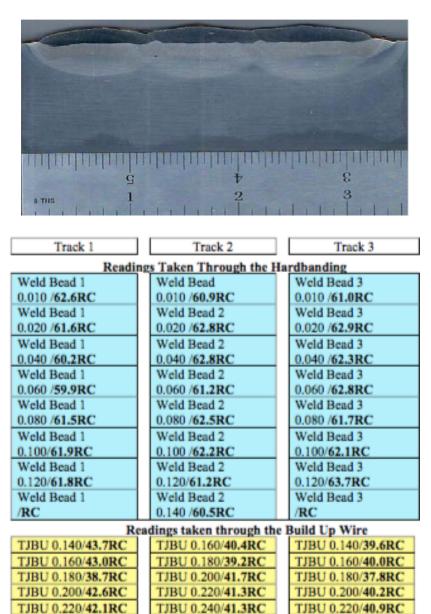
Hardness report #LR2715 Tool Joint TJBU and Duraband NC

Testing equipment: Tukon 2500 Certification expires: 1/19 Readings converted from Vickers HV0.5, reported in Rockwell C scale

Testing Performed by Postle Industries, Cleveland, Ohio.

TJBU 0.260/43.5RC
